Doc #: 202305-05592 Inspector: Michael C. Schirmer
Date: 6/1/2023
Dwelling Address: 333 Route 2
South Hero Vermont
Client Name: South Hero Town Hall
Naomi King
townclerk@southherovt.org
Client's Agent: N/A; Condition Report

Built on a flat lot; Commercial Building.
 Structure is facing North.

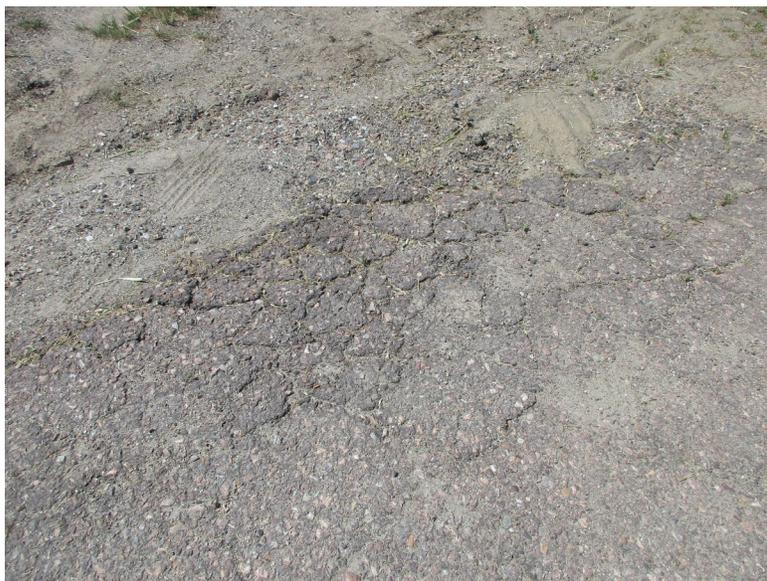
Component	Comments
0101.	Driveway	MAINTENANCE. Crackfilling and sealcoating is coming due. Areas of crumbling is beyond normal crackfilling in sealcoating maintenance. These areas will need to be replaced as part of other work.

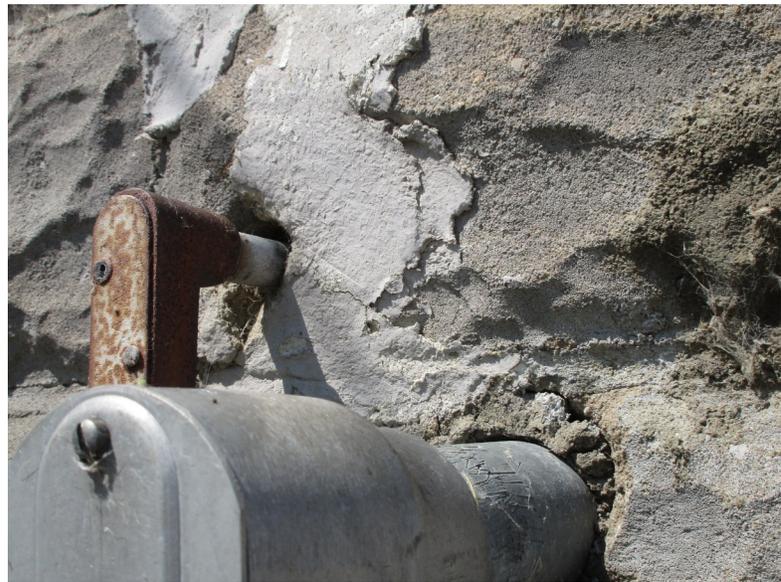
Missing caulking at all areas where cinderblocks and trim meet, including around all windows and door moldings. Without weeps (drainage in the bottom course of blocks), sealing around openings is imperative. Suggest caulking be performed to avoid water intrusion.

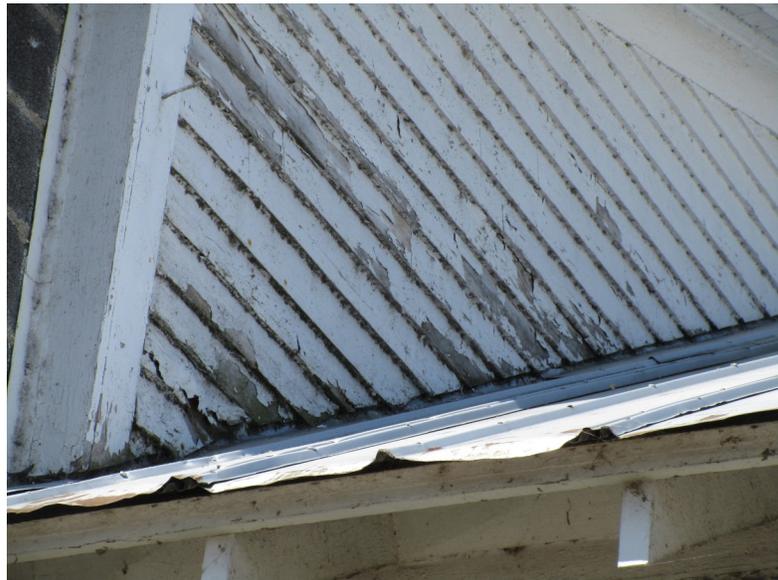
Moisture damage/softwood observed on the left dormer tails.
Suggest further review by qualified Carpenter for replacing rotting wood as needed to avoid further damage.

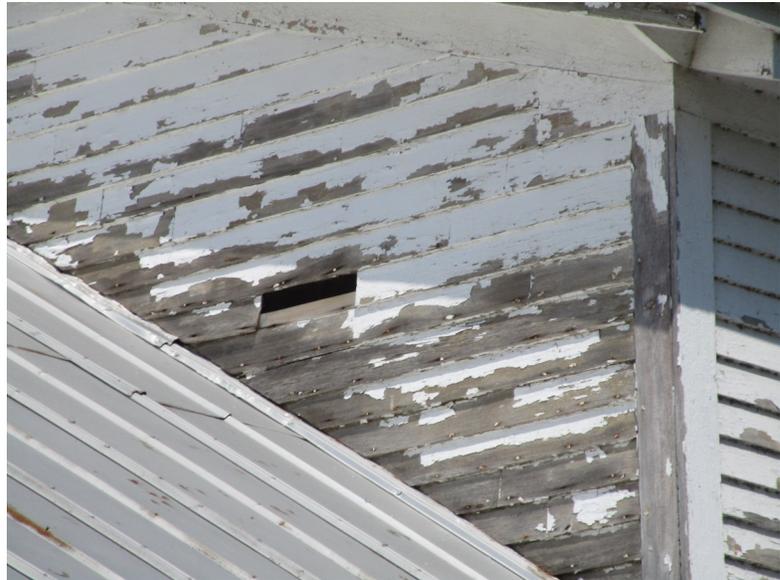
Missing siding is observed on the backside of the left dormer.
Expose sheathing is noted. Recommend replacing missing siding to avoid moisture penetration to the sheathing and substructure.

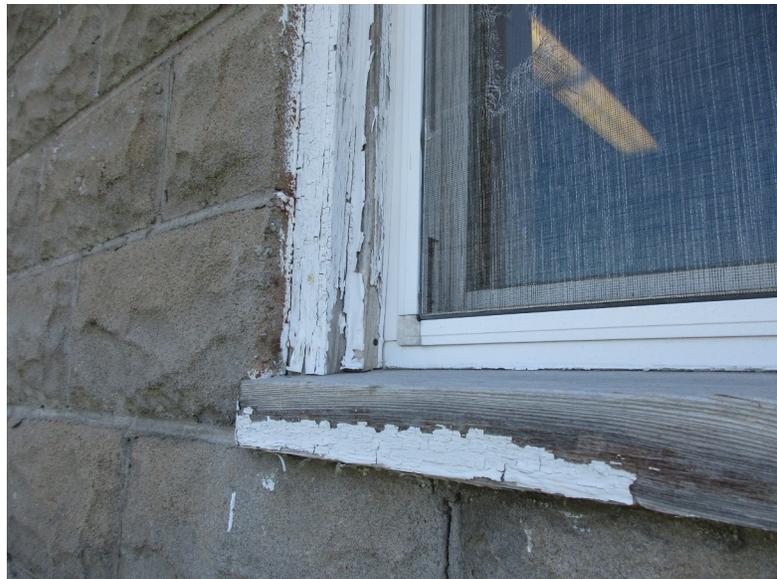
Paint is peeling ALL areas of frames and sills.
Bare wood is noted. Painting, with proper preparation and caulking should be anticipated to preserve the wood and prevent further deterioration.

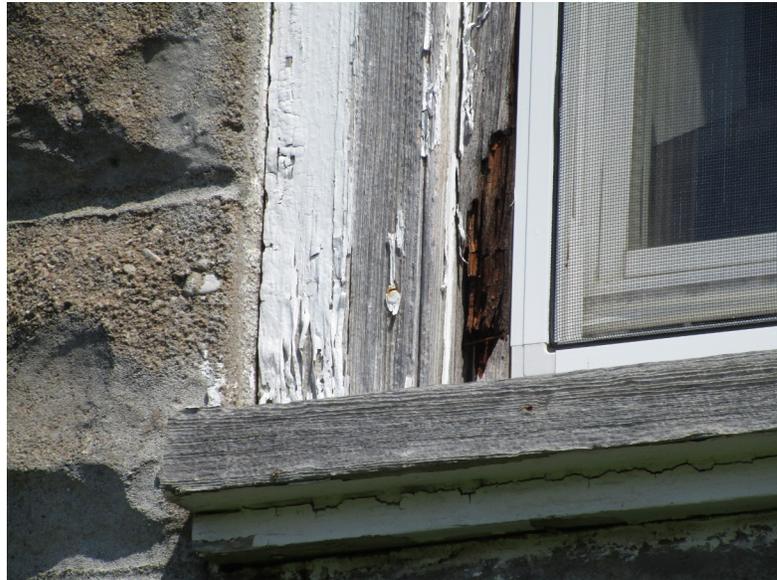
Moisture damage/soft wood is observed on the rear leftward window casing.

Suggest further review by qualified Carpenter for replacing rotting wood as needed to avoid further damage.

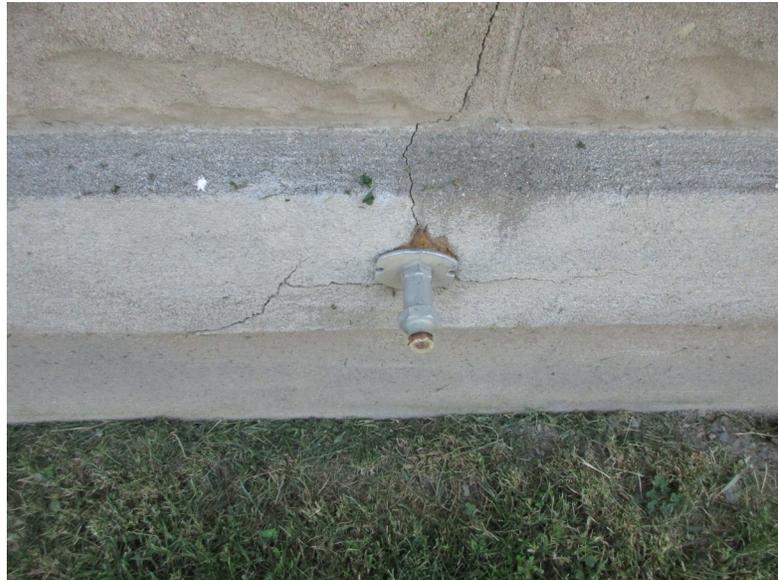
The hosebibb valve handle is missing.
Not operationally tested.

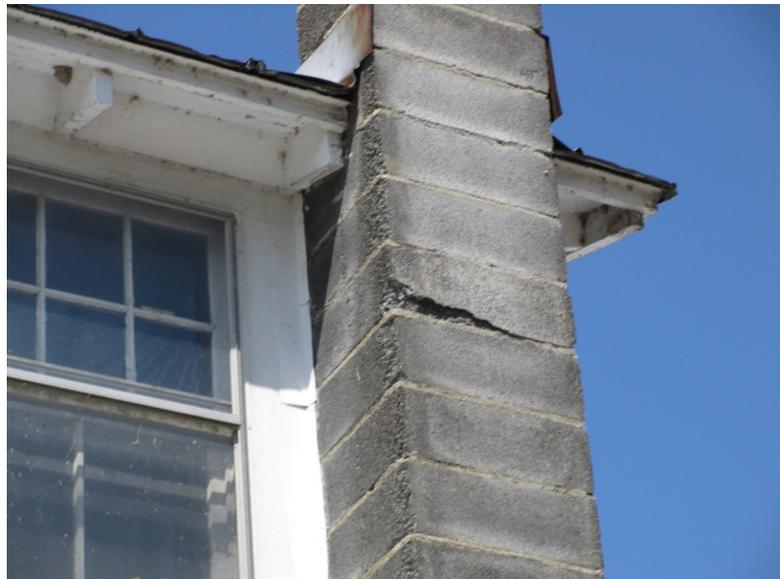
No appliance is connected to this chimney. We recommend a full Class II chimney inspection if recommissioning.

Patch spalling chimney block to preserve the chimney structure.

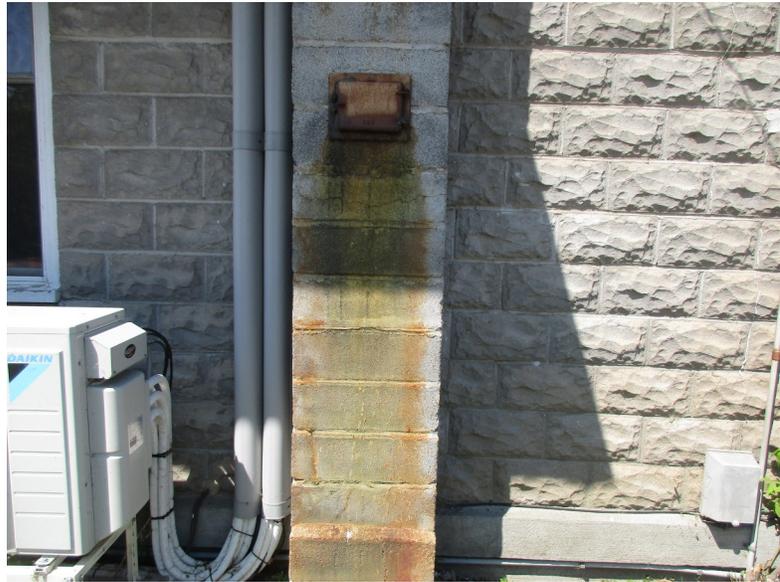
Water staining from the cleanout door is indicative of soot and ash exceeding the cleanout door.

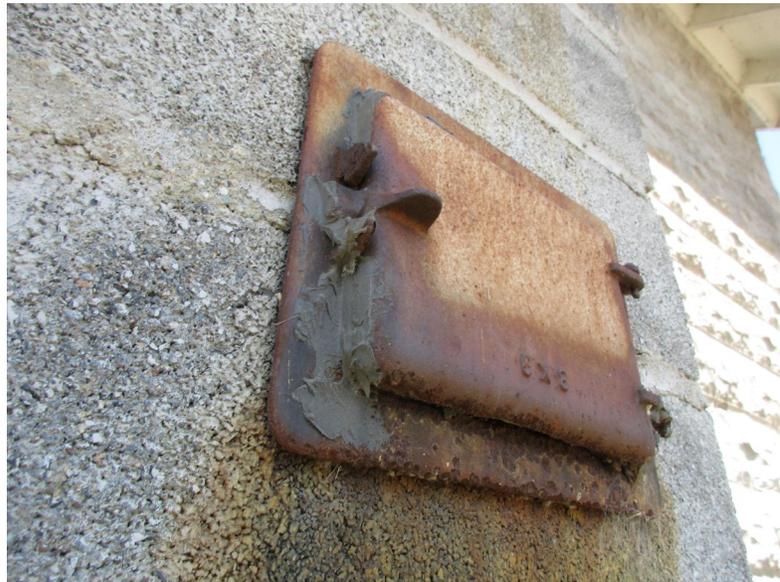
The cleanout door cemented shut further limits our review.

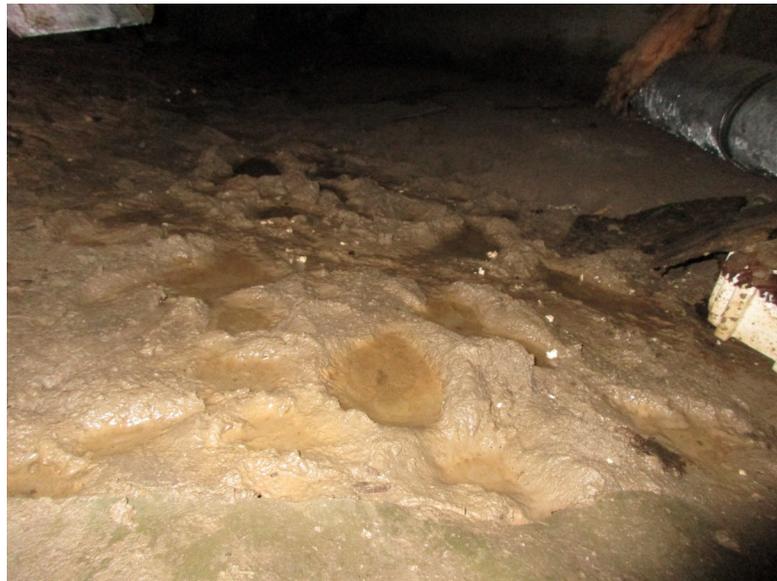
Component	Comments
0701.	Access	ACTION. Access is located in the under-stairs closet floor scuttle hatch. Unable to access crawlspace fully due to standing water in ALL areas. Standing water and mud limits our review.

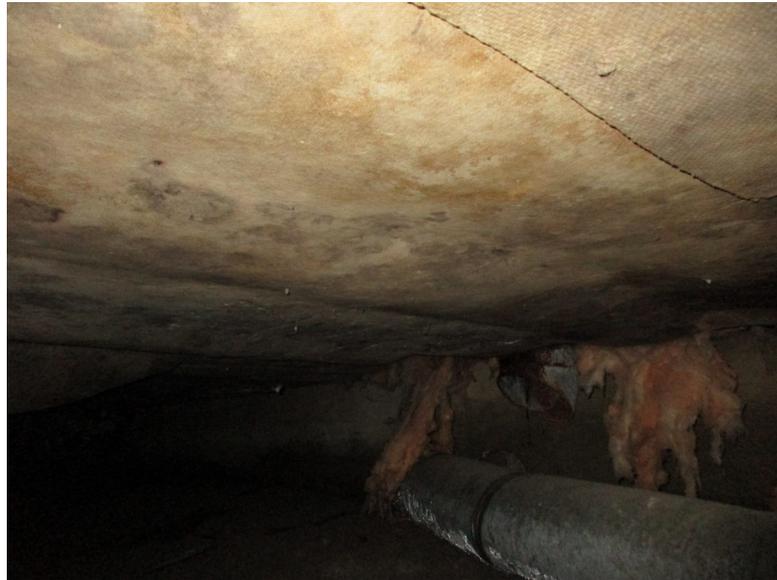
Finished areas noted in the crawlspace.
Access to the original basement ceiling was not available due to wet/saturated/moldy Homasote (fiber board) now present.

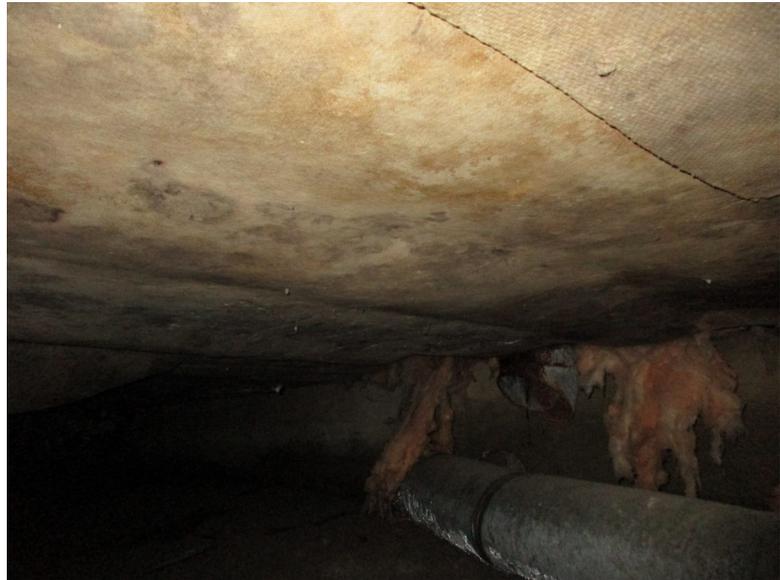
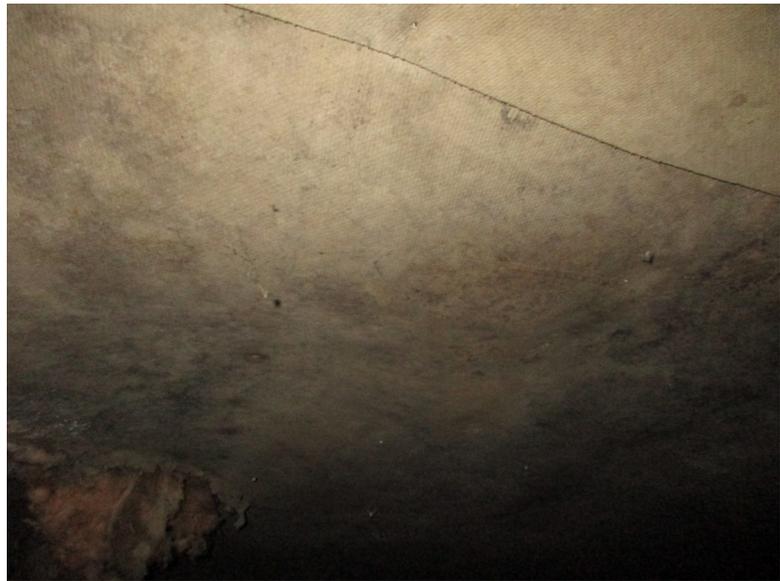
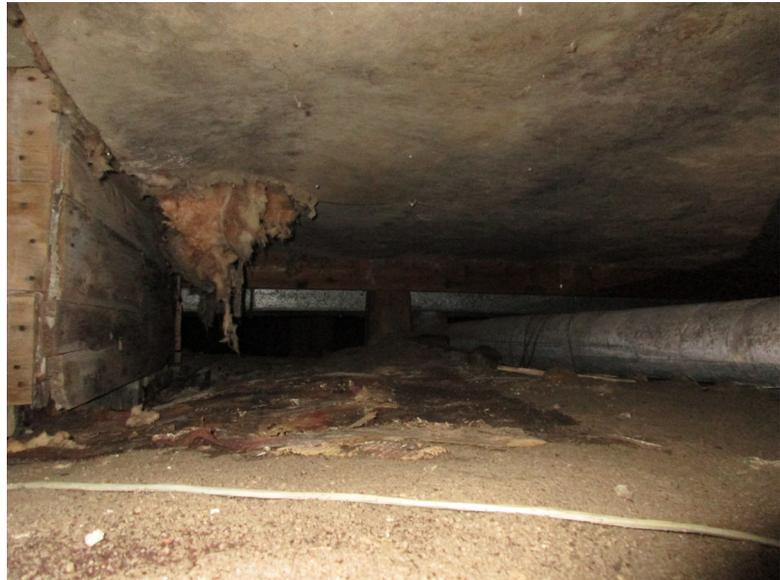
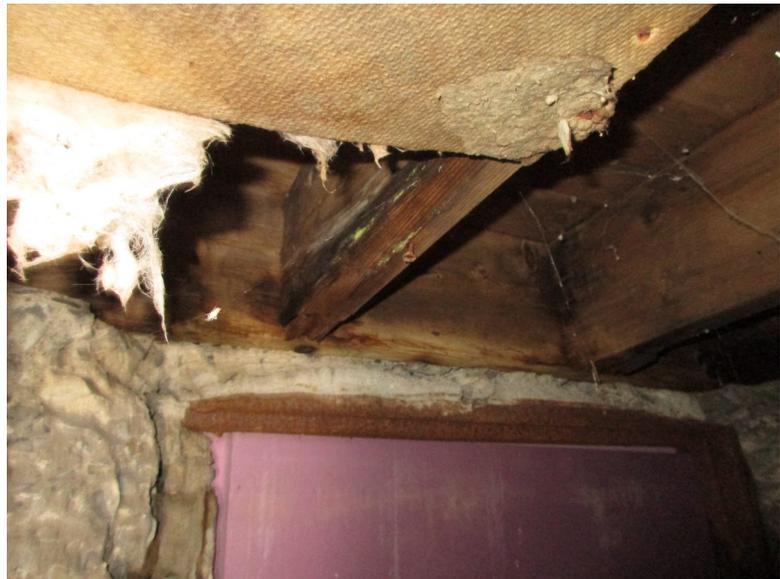
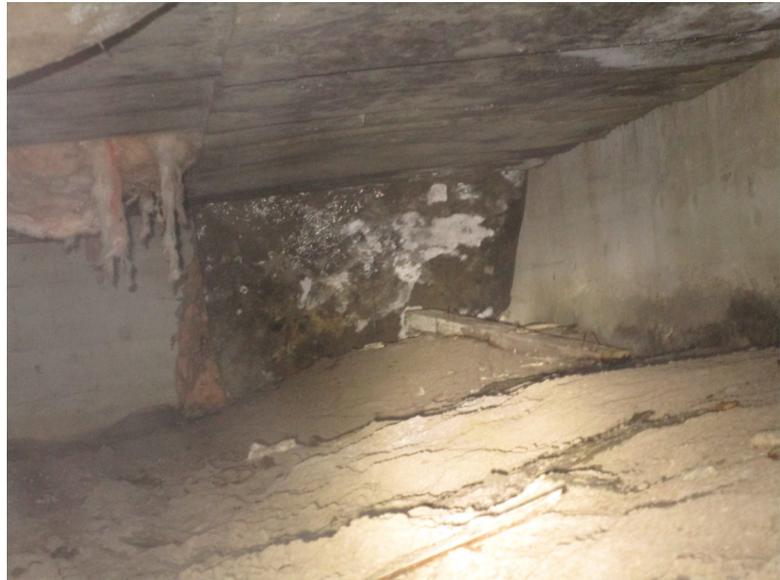
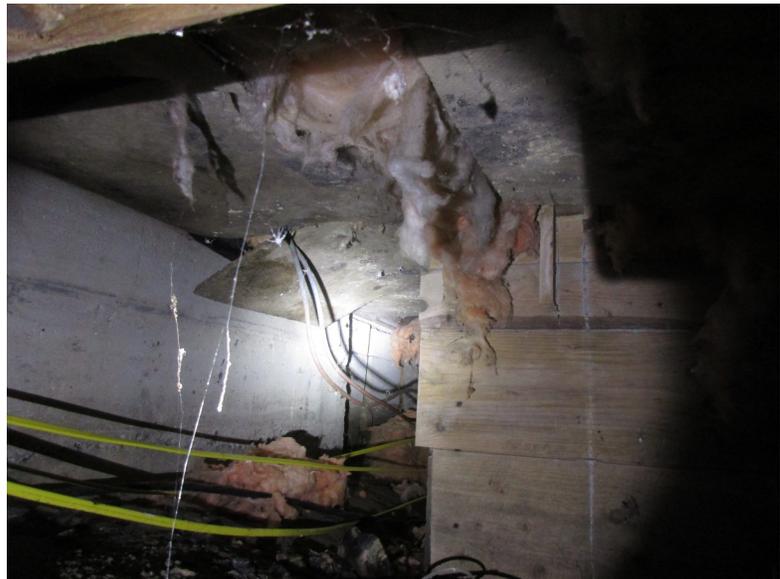
Standing water and mud is observed ALL areas of crawlspace.

A crawlspace must be kept clean and dry to avoid moisture damage and wood deterioration to the structural beams and joists of the building.

According to the US Environmental Protection Agency, when the amount of mold exceeds 9 ft.² - remediation should be performed by a flood damage/mold remediation professional.

Suggest further review by a qualified basement contractor for repairs as needed to ensure a dry basement.

Due to the amount of mold, it is your inspectors' opinion that the mold must be professionally remediated. Consult a qualified mold remediation company to contend or concur with our assertion and discuss remediation options with you.

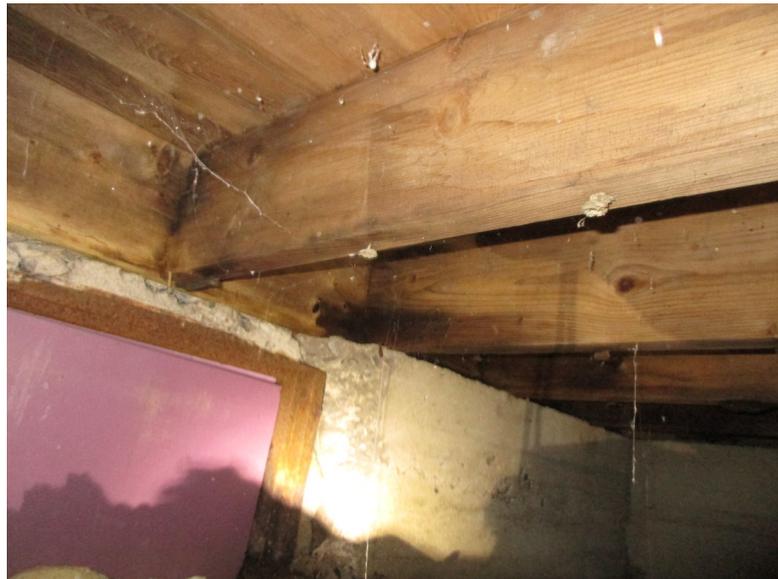
It appears that due to the flood damage, moisture rot is present on all visible floor joists at their end bearings on the foundation.

A lost sill plate may have allowed the floor joists to drop 2 inches; and the wet bearing ends, now sitting directly on the cement foundation, are beginning to shear off. This is a major structural concern as shearing floor joists may be pushing outward against the top of the right foundation wall and across the bottom of the right structural wall of the building. Unable to determine the extent of damage without destructive investigation.

It is your inspectors opinion that a large number of floor joists at their end bearings will need to be jacked back into position and reestablished as part of other flood damage repairs. Consult a qualified structural contractor to contend or concur with our opinion and discuss building-saving options with you.

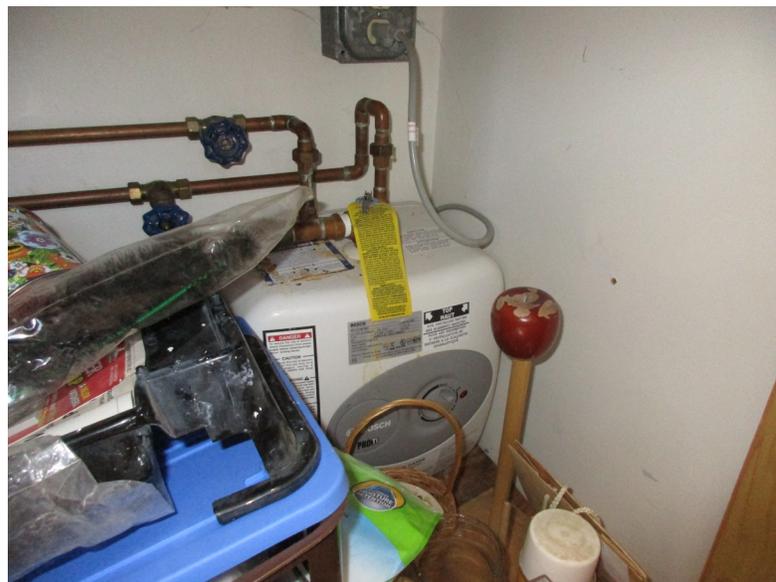
Hot water was noted at all tested plumbing fixtures indicating the electric water heater elements were functioning properly at the time of inspection. These elements are not visible or accessible to the inspector and are not specifically tested at the time of inspection. No warranty, guarantee or certification is given as to future failures.

The general life expectancy of a water heater of this type is 8 to 12 years. Be aware that this water heater is 27 years old. We recommend monitoring and begin budgeting for replacement soon.

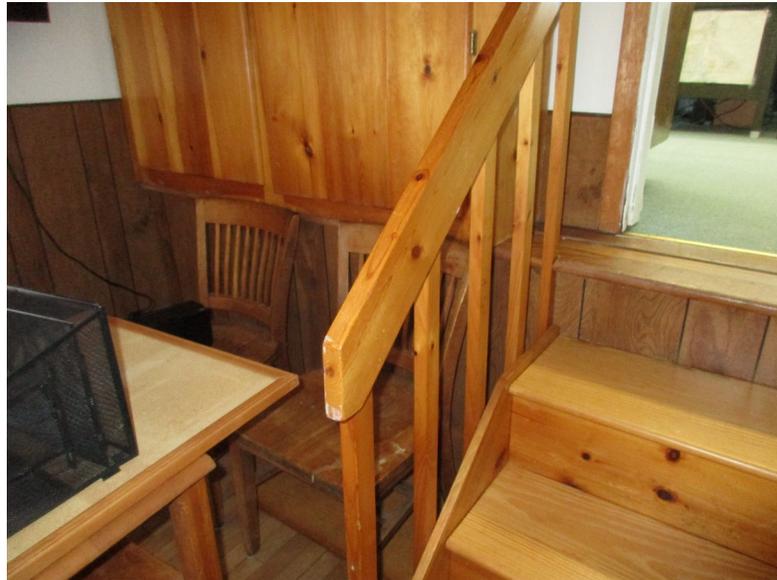
No guard railings are present at the open side of stairs.
Caution should be observed to ensure safety.

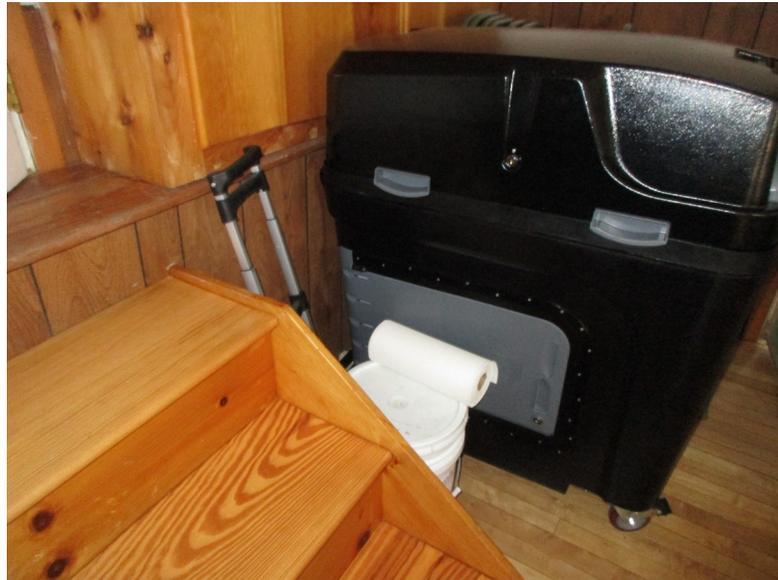
No landing present at the top of stairs.

A door should NEVER open out over a staircase. This is a fall hazard. Recommend reversing the swing of this door or installing a landing as a safety enhancement to the property. This would be required as part of the Vermont Department of Public Safety inspection.

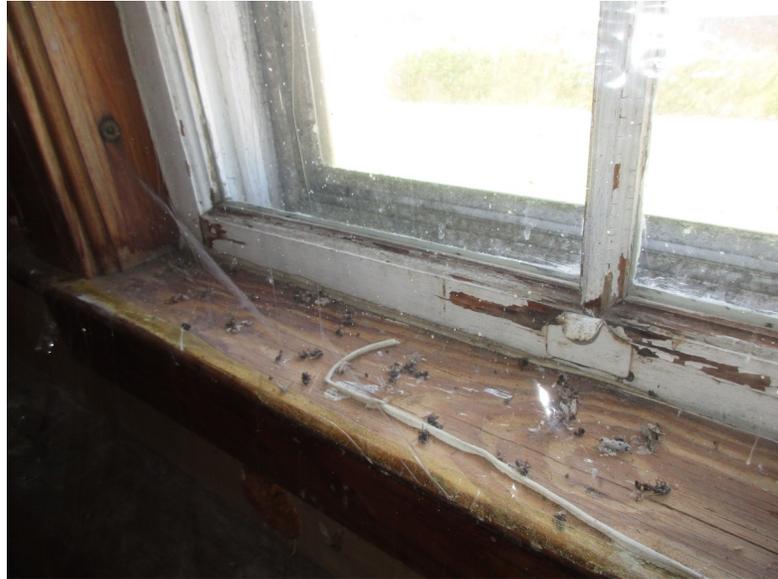
Alligating, chalking and flaking paint observed at all second floor windows.

Maintenance and protection is needed to ensure that the painted surfaces are safe. If client has concerns regarding lead in paint, we recommend contacting the State of Vermont Lead Hotline at 1-800-439-8550.

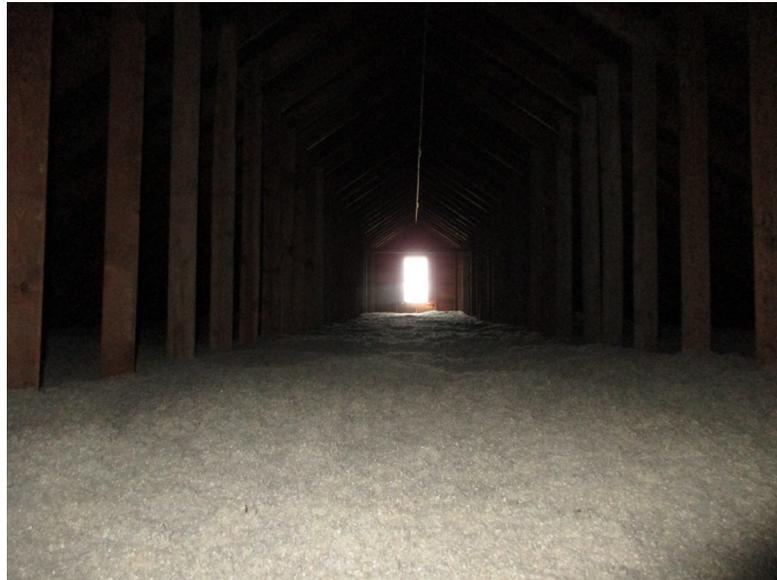
0405. Ventilation

Venting appears to be inadequate.
