Doc #: 202305-05592 Inspector: Michael C. Schirmer
Date: 6/1/2023
Dwelling Address: 333 Route 2
South Hero Vermont
Client Name: South Hero Town Hall
Naomi King
townclerk@southherovt.org
Client's Agent: N/A; Condition Report

Built on a flat lot; Commercial Building.
 Structure is facing North.

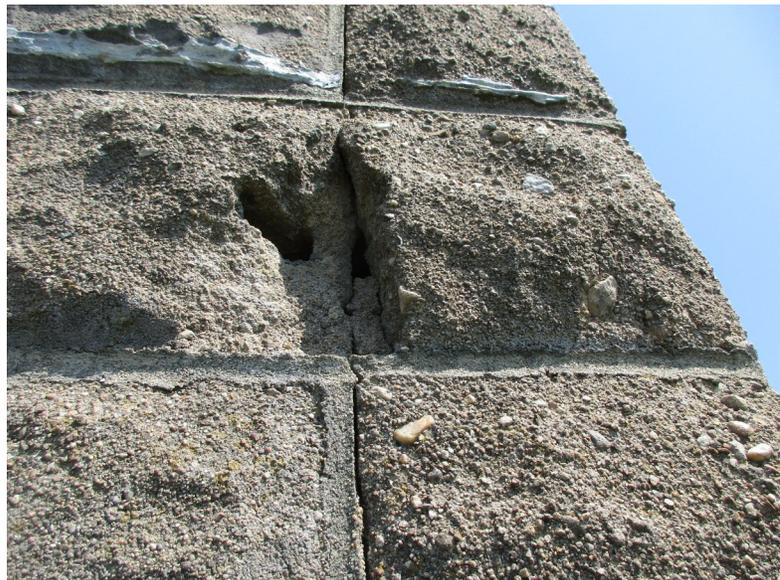
A rear leftward cinderblock as spalled away (1 block). Exposed hollow core noted is a structural concern. This cinderblock will need to be replaced as part of other exterior cinderblock work.

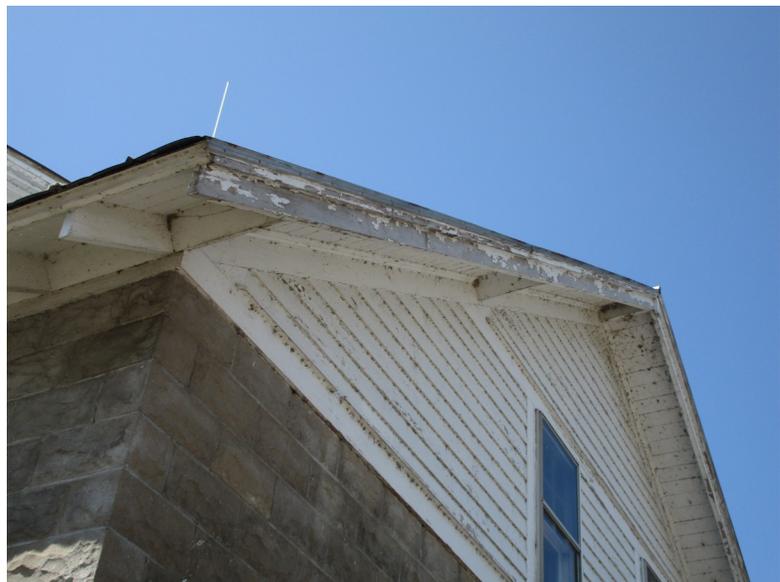
Paint is peeling ALL areas of fascia, soffits, and barge boards.

Bare wood is noted. Painting, with proper preparation and caulking should be anticipated to preserve the wood and prevent further deterioration.
